## INTRODUCTION

In this guide we will take a look on how to open the device, where the most common leaking parts are, and how to clean and/or replace them.

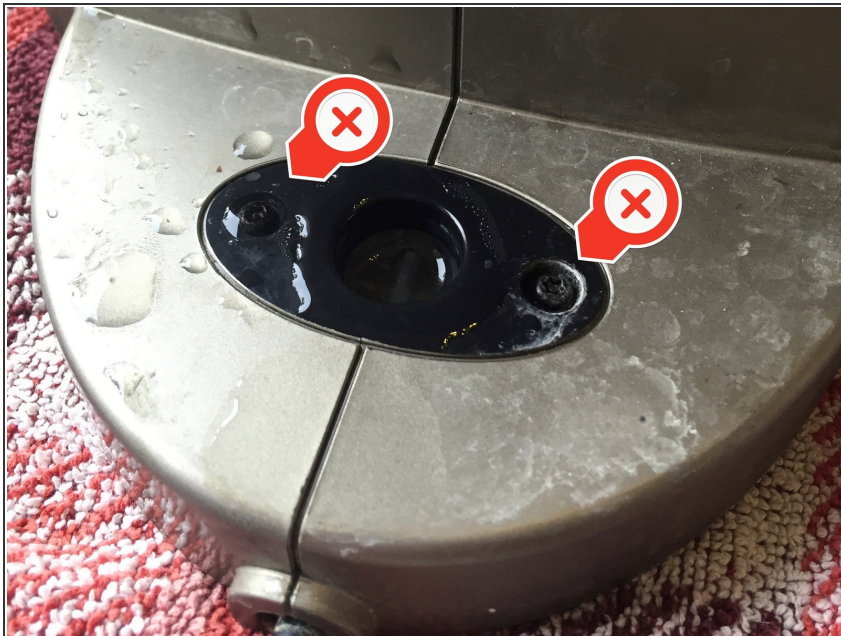
## Step 2 — Opening it up (2)

- Remove the two TR10 screws from the bottom part

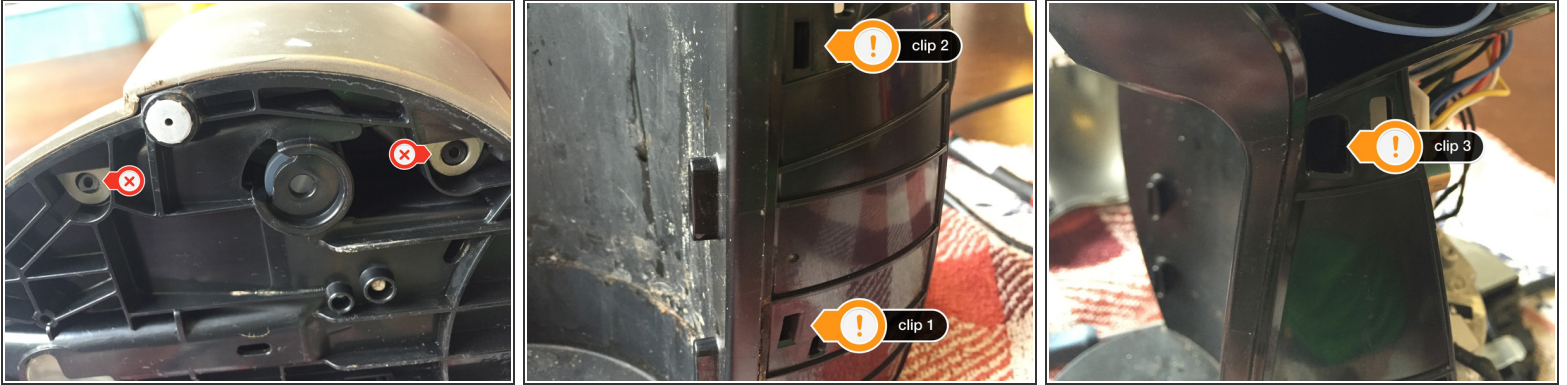
### Step 3 — Opening it up (3)

- With the back of the device towards you, start on the left panel
- It is connected with 6 clips at the lower part, and several more for the top part
- Carefully pry loose the clips from the bottom upwards, starting with the clips on the bottom (red arrows)
- next open up the clip next to the power cord
- open up the three clips on the side of the panel (orange arrows). Locktabs grip the holes in the orange clips 1 and 2. They will let go if they are lifted directly outwards from their base. Just next to the locktabs are guide pins. they don't offer resistance during removal.

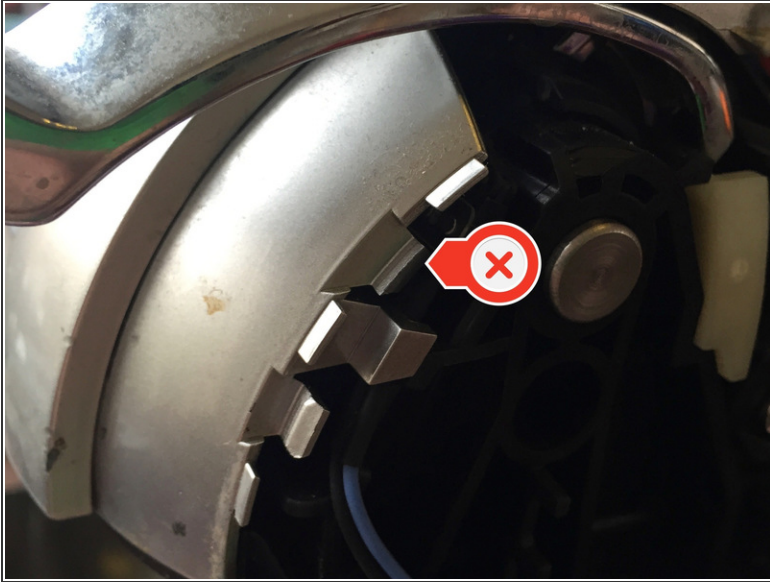
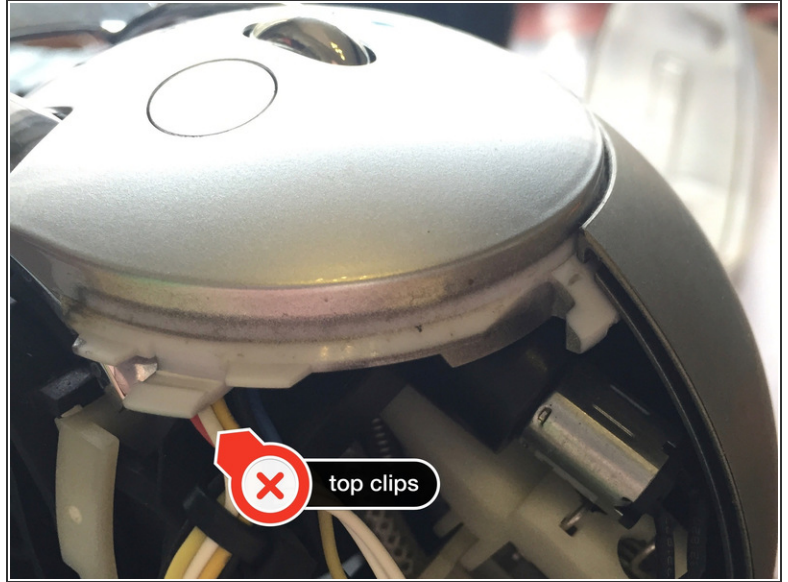
## Step 4 — Opening it up (4)

- Now continue with the top part. It is connected at two places, with a big mess of clips and placeholders. Some force might be needed to pull them apart.
- First tackle the bottom row of clips (red arrow)
- Then pry the top row apart (other red arrow)
- You can now remove the entire left side and put it aside

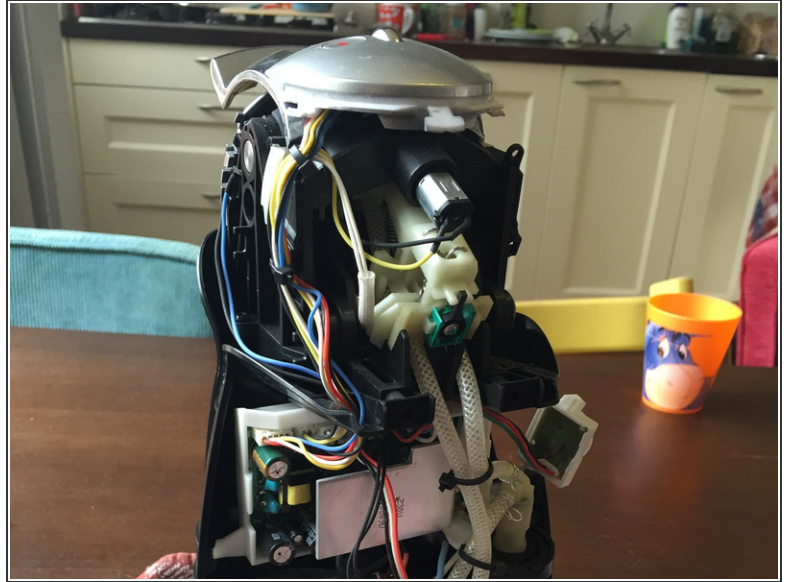
## Step 5 — Opening it up (5)

- Remove the right side following the same procedure as for the left side. Once the right side is fully loosened, disconnect the power button from the panel. It is held in its place by two small clips, which are easily loosened with the flathead screwdriver or spludger.
- We now have full access to the penguin's innards!

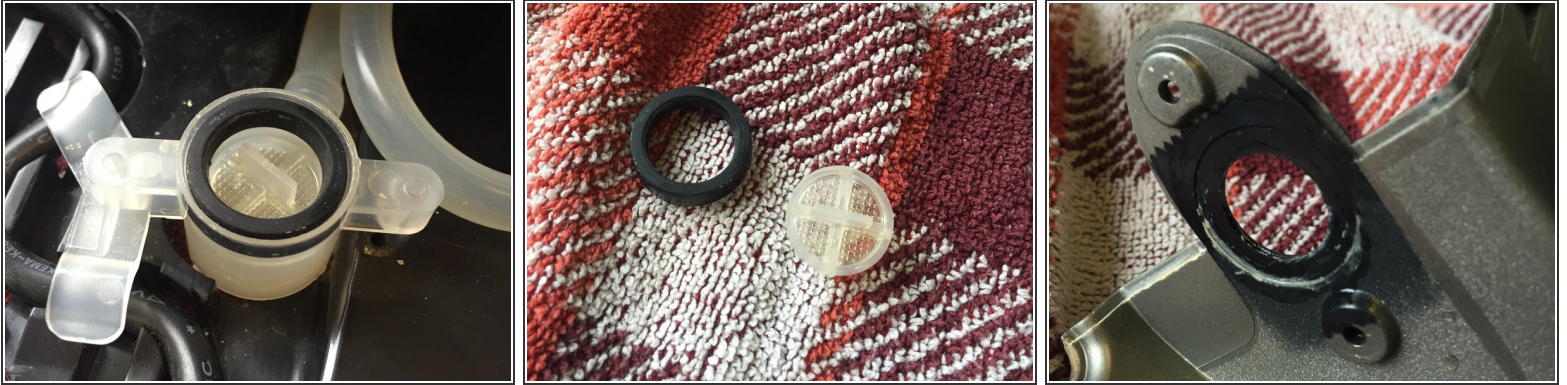
## Step 7 — Cleaning the connector assembly

- Loosen the connector assembly. It is not glued or held back by clips, so a slight wiggle is enough to pull it.
- Pull out the sealing rubber and filter
- Carefully but thoroughly clean the housing, the seal and the filter of any calcified remains.
- Clean the underside of the housing where the assembly is connected to the housing. Remove all calcified remains from here as well
